Study of Army Aircraft Maintenance-Related Mishap Experience

November 1981

U.S. ARMY SAFETY CENTER

DOC 81-11

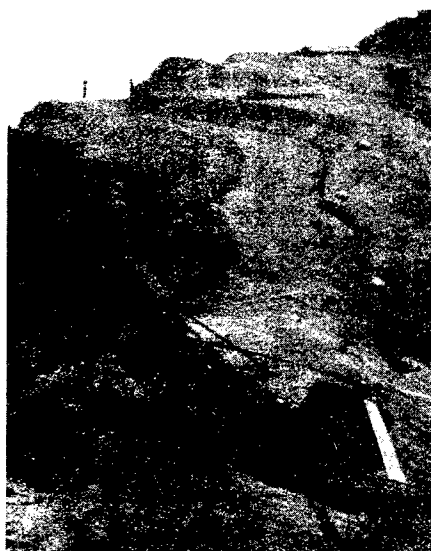
During CH-47 slingload operations over mountainous terrain, all aircraft systems were responding normally as the crew made a shallow approach to the top of a ridge.

The copilot then made a descending turn to a relatively level area. As the aircraft touched down, a blade strike caused one blade to fail at the fourth pocket from the root, allowing it to fold upward. This induced severe vibration, causing the aircraft to bounce and slide toward the edge of the ridge. The aircraft's movement was finally halted when the right front and rear landing gear sank into soft earth and gravel. Total cost for repairs was estimated at more than \$850,000.

Investigation revealed the No. 1 engine trim system malfunctioned because the pilot's No. 1 engine beep trim switch had been improperly installed. Further, the aircraft had not been placed on a red X status when the engine trim system had previously malfunctioned, during which time the switch was replaced. As a result, the maintenance work was not inspected by a TI nor was a maintenance operational check performed as required by TM 55-1520-227-23-2. ■

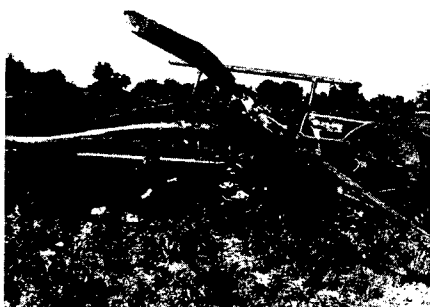
With one passenger on board, the pilot of an OH-58 attempted a left hovering turn when he noted that the left control pedal bottomed out prematurely. The aircraft then began spinning uncontrollably to the right. The pilot increased collective and attempted to fly out of the spin. This spin was unsuccessful and when the low rpm audio sounded, the pilot decreased collective to set the spinning aircraft on the ground.

During the landing attempt, the main rotor struck the ground and the aircraft rolled on its right side. Both occupants exited through the left crew door without injury. The aircraft was destroyed.

Investigation revealed that maintenance personnel used improper procedures during the installation of the tail rotor pitch change control tube, P/N 206-011-724-1. This resulted in one roller becoming dislodged from the control housing roller bearing, P/N 206-011-731-1. During flight, the dislodged roller became trapped between the pitch key, P/N 206-011-704-1, and the end of the key slot, restricting left pedal movement of the pitch control tube by approximately 7/16 inch. This resulted in insufficient antitorque control. ■

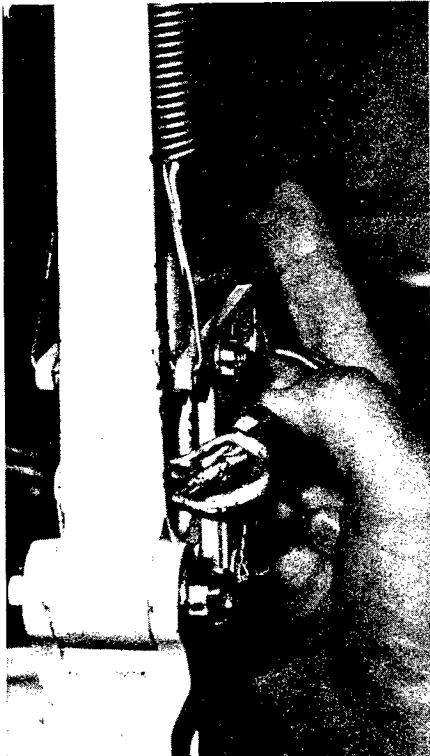
Following takeoff, the pilot of a U-8F placed the gear selector handle in the up position, but the gear did not retract. Because of heavy air traffic in the vicinity of the airfield, the crew became engrossed in making radio calls for an IFR clearance and failed to notice the gear remained in the extended position. Consequently, climb to cruise altitude was continued for several minutes with the gear extended before the crew noticed the red light in the gear handle. They then attempted to recycle the gear without success.

Following rollout, the pilots decided to turn off the active runway before shutting down the aircraft and calling on maintenance personnel for assistance. As they began their turn, the right main gear started to collapse, then the left. The aircraft settled on its belly and skidded approximately 3 feet before stopping. The nose gear remained down and locked. Damage to the aircraft was estimated at approximately \$24,000.

Investigation revealed that the mechanic who performed the daily inspection had noted the nose gear downlocks needed adjustment. So he removed the forward end of the drag brace and filed the downlock hook to obtain the necessary clearance. While performing the needed maintenance, he was interrupted twice—first, to refuel the aircraft, and second, to assist another mechanic on a different aircraft. Following the first interruption, the mechanic reconnected the drag brace, installed the attaching bolt, and finished the job by safetying the nut on the connecting bolt with a new cotter pin. At this time he was called to assist another mechanic and did not return to the U-8. As a result, no entry was made in the aircraft log and the nose gear was not inspected.

Unfortunately, when he reinstalled the forward drag brace bolt, he inadvertently failed to insert it through the hole in the drag brace. Consequently, during the

retraction attempt following takeoff, the drag brace could not unlatch the downlocks so that the nose gear could retract. As a result, binding of the gear drive system occurred immediately after the main gear unlocked and started to retract. This binding condition caused the drive motor clutch to slip until the landing gear motor overheated and tripped the system circuit breaker. This completely disabled the system with the main gear in an unsafe condition.

The additional load imposed on the engines by the extended gear while the aircraft remained in a climbing attitude for several minutes caused the left engine to overheat, detonate, and surge.

Although the pilots failed to follow the emergency procedures checklist which would have allowed them to manually extend and lock the main gear, preventing the accident, failure of the mechanic to correctly install the nose gear forward drag brace bolt precipitated the events that led to the accident. These events could still have been prevented had the mechanic been allowed to complete his work without the interruptions that occurred. These interruptions prevented him from making any entry in the aircraft log, and allowed the aircraft to be flown without an inspector's approval. ■

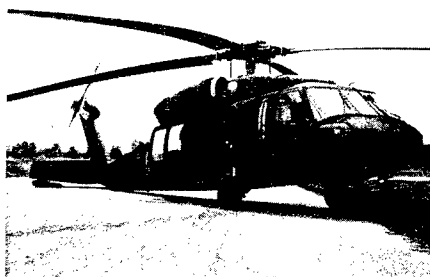
The pilot of a UH-60 was attempting a roll-on landing when the aircraft began to yaw to the left. The IP took the controls, corrected for the left yaw, brought the aircraft to a hover, and applied right pedal to align the aircraft with the lane. The aircraft immediately began to yaw to the right. The IP applied full left pedal but the aircraft continued to spin to the right at an increased rate of acceleration. Unable to check the spin, the IP leveled the aircraft, reduced collective, and set the aircraft on the ground. On landing, the tail wheel broke and separated from the aircraft, causing damage to the fairings and left stabilator. Cost for repairs was estimated to be approximately \$25,000.

A check of maintenance records showed the oil cooler fan had been replaced several months before the mishap, during which period the aircraft had accumulated 183 hours of flight. Investigation revealed that the oil cooler fan exit flange failed in flight, disconnecting the tail rotor drive shaft. This resulted in loss of directional control. Further investigation determined the oil cooler fan exit flange failed because of excessive shaft runout—the result of misalignment.

Maintenance personnel did not check shaft runout following the oil cooler fan installation as required because of inadequately written maintenance procedures. TM 55-1520-237-23-7, Task 46, was found to be deficient in format and lacking in detail. In addition, a required special tool was omitted from the tool list. Collectively, these deficiencies made it appear that Task 46 was completed upon the installation of the oil cooler.

Following the investigation of this mishap, runout checks were performed on seven other UH-60 aircraft on which oil cooler fans had been replaced. The shafts on five were found to be out of alignment. ■
